Corrosion-wear studies on PVD coatings for aeronautical applications.

R. Bayón, A. Igartua, U. Ruiz de Gopegui, G. Mendoza

*Fundación **TEKNIKER** (www.tekniker.es), Avda. Otaola 20, Eibar, Spain*

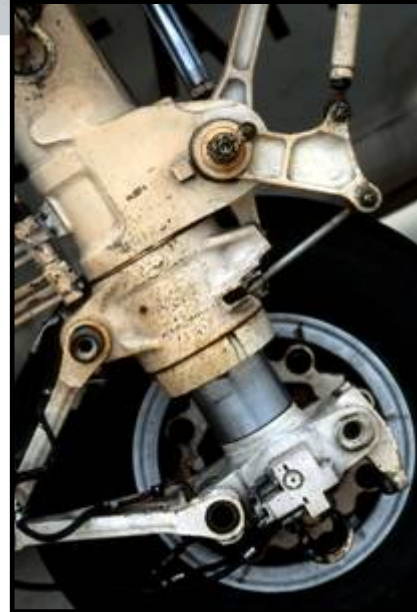
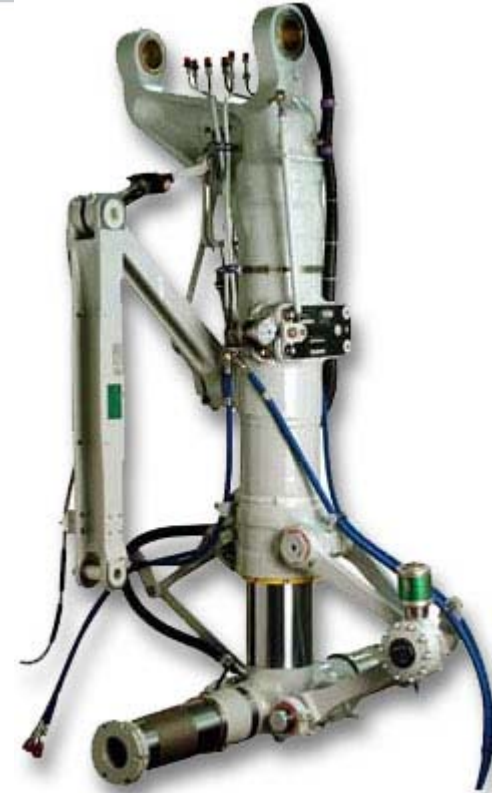
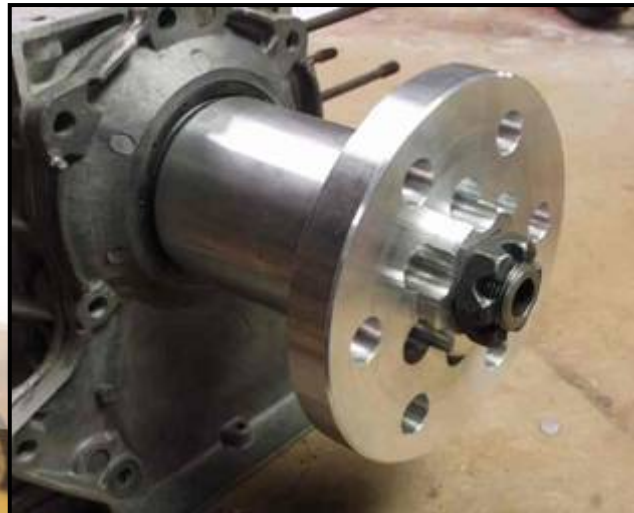
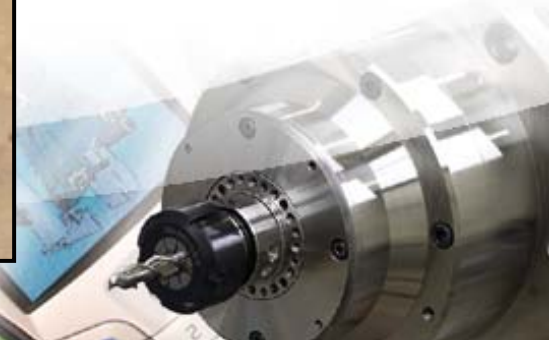
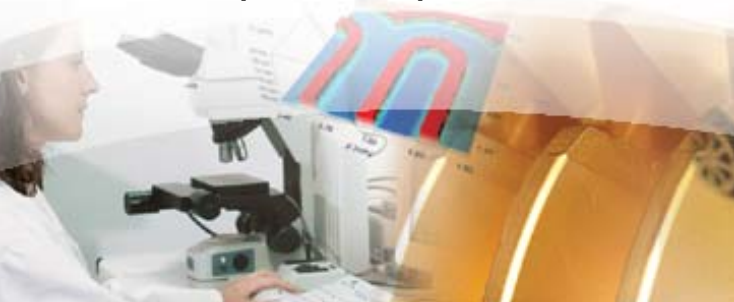
Examples

- ✓ Landing gear
- ✓ Engine components
- ✓ Propeller hubs
- ✓ Actuators
(hydraulic/pneumatic actuators used throughout aircraft)
- ✓ Helicopter *dynamic components* (including gearboxes, rotor reads and damper components)

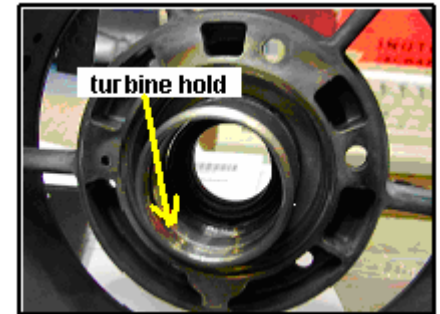
Tests on real Component-Fretting at 400°C against AMS 6491

- ➔ Monolayer of **CrN** by PVD catodic arc
- ➔ Multilayer of **TiN/CrN** by PVD cathodic arc

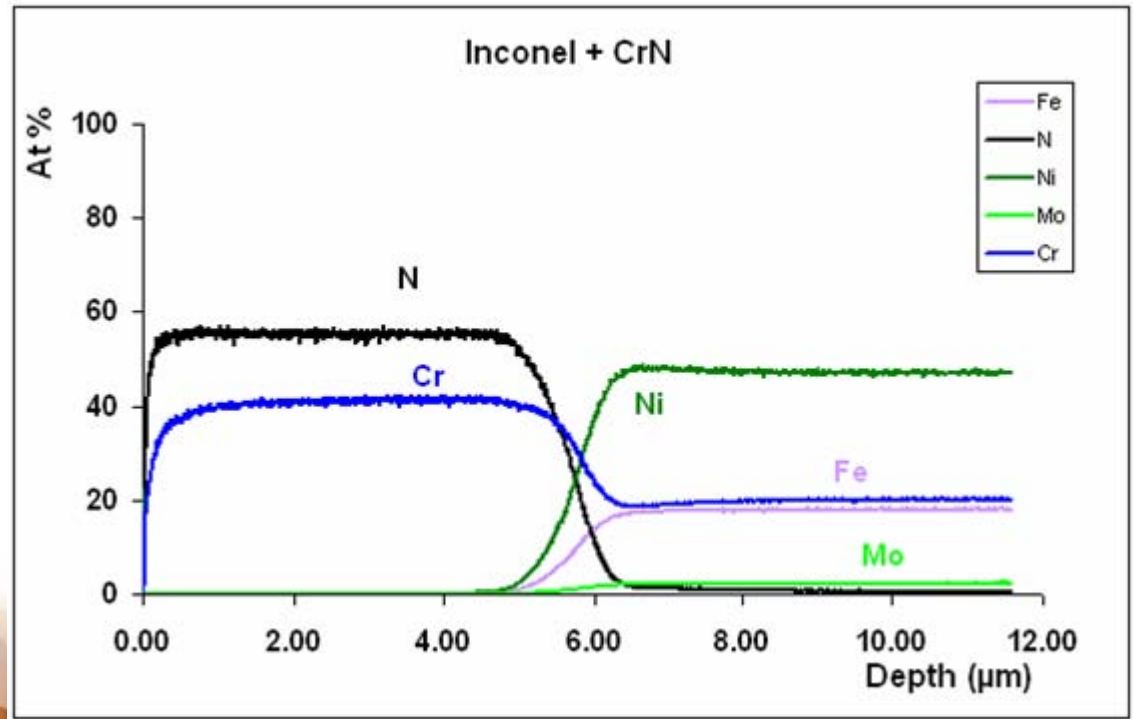
GD-OES

- Inconel+ CrN monolayer

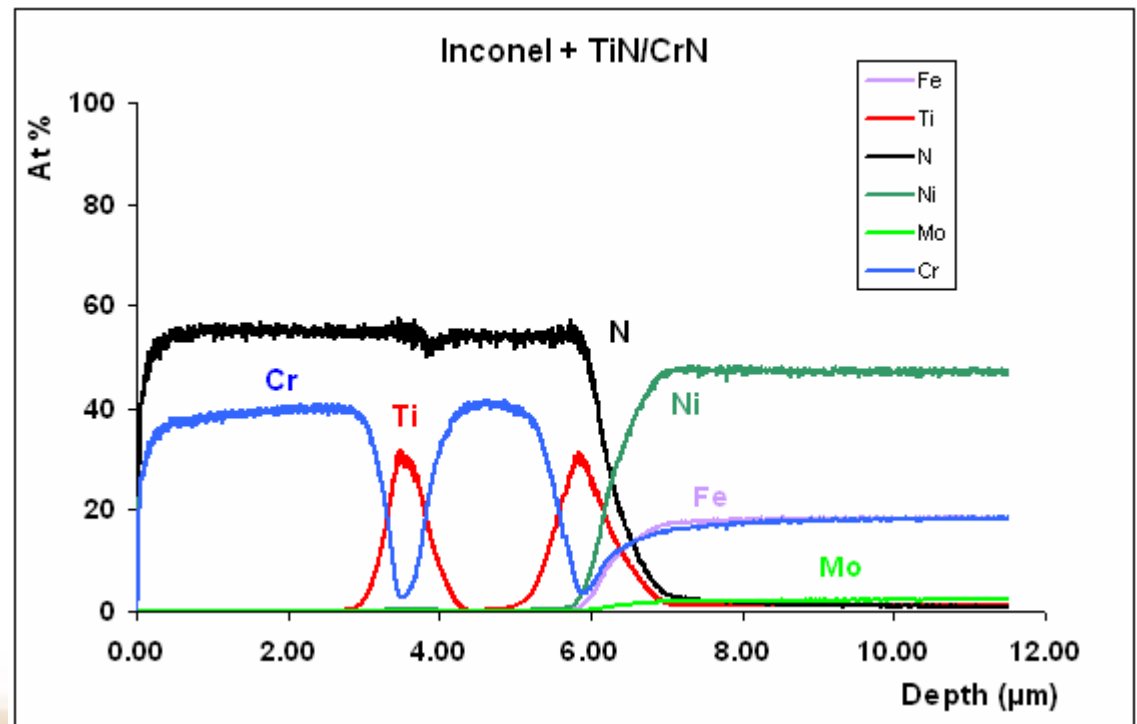
GD-OES

● Inconel+ TiN/CrN multilayer

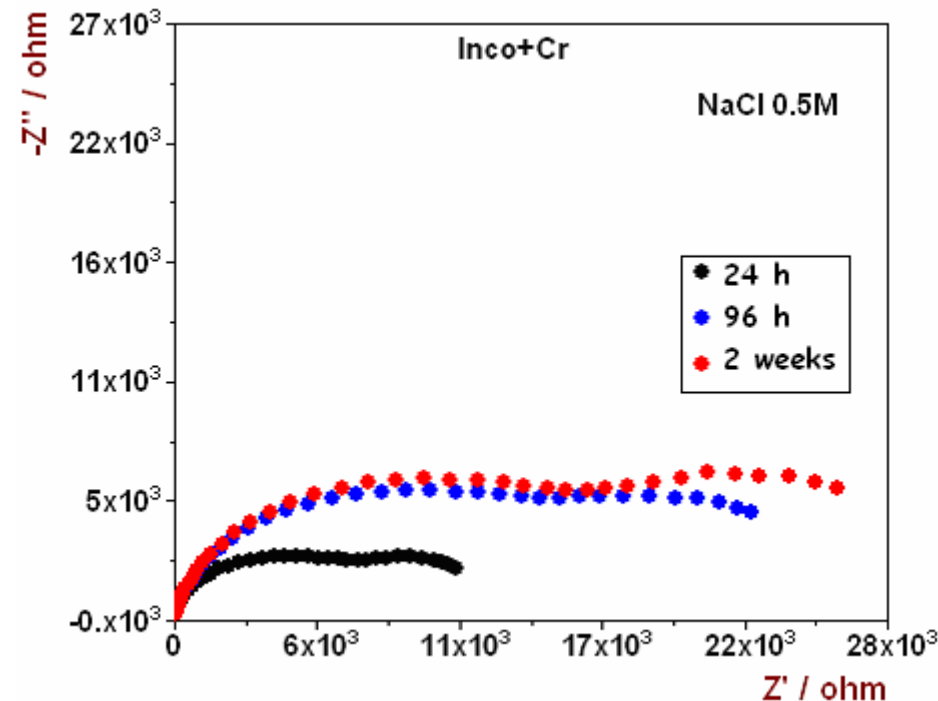
Corrosion Results: EIS measurements

- ✓ Improvement of surfaces electrochemical resistance with immersion time
- ✓ Good corrosion behaviour of both surfaces (~ 4MΩ and 50 kΩ respectively)

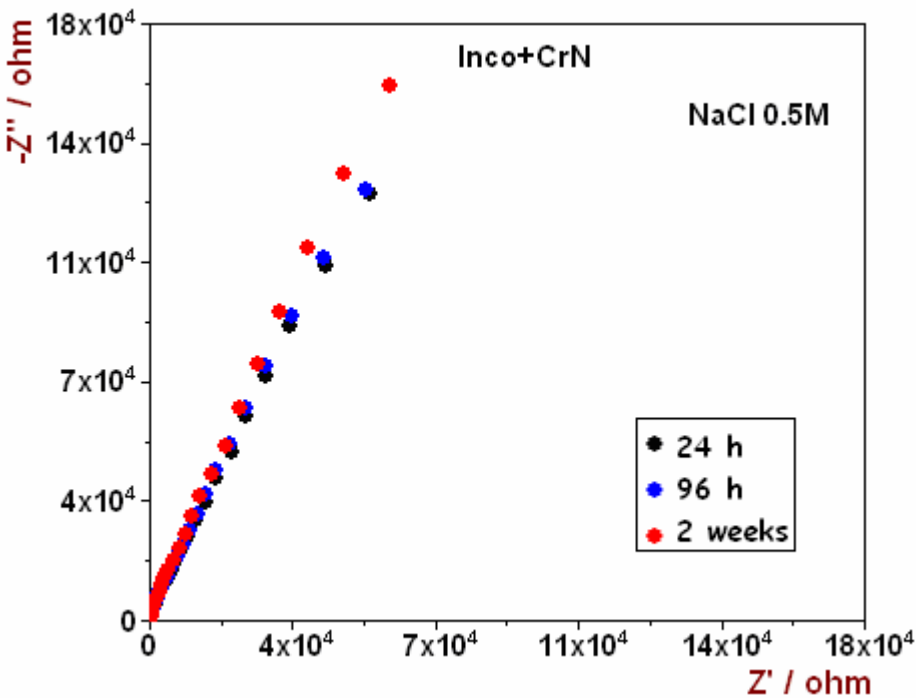
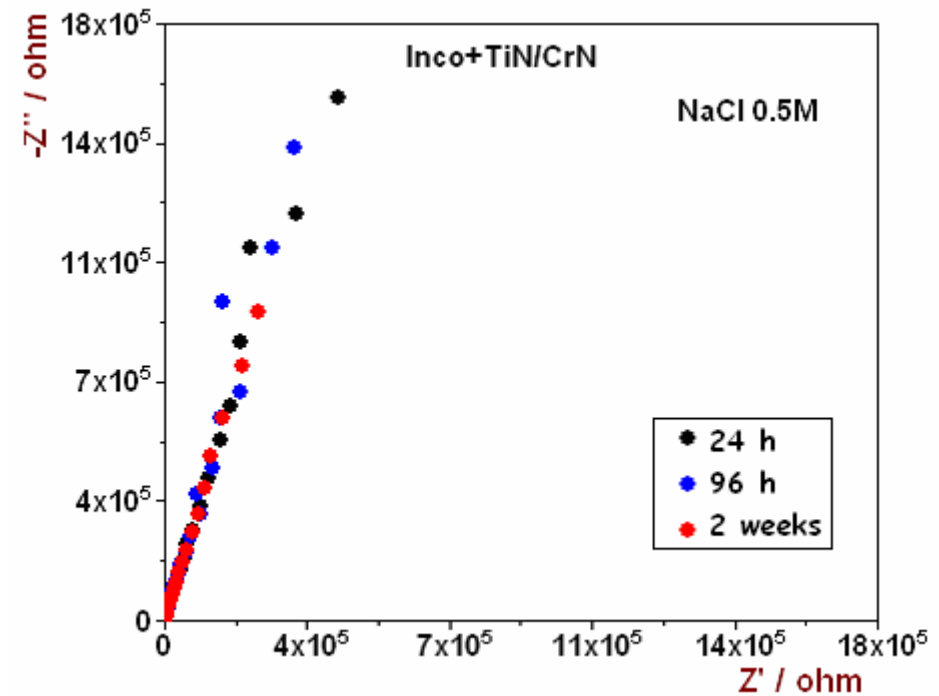
EIS measurements on PVD coatings

- ✓ Similar behaviour during the total exposure to the aggressive media
- ✓ Capacitive behaviour, *corrosion resistance* of the order of **10MΩ**
- ✓ No coatings porosity is detected

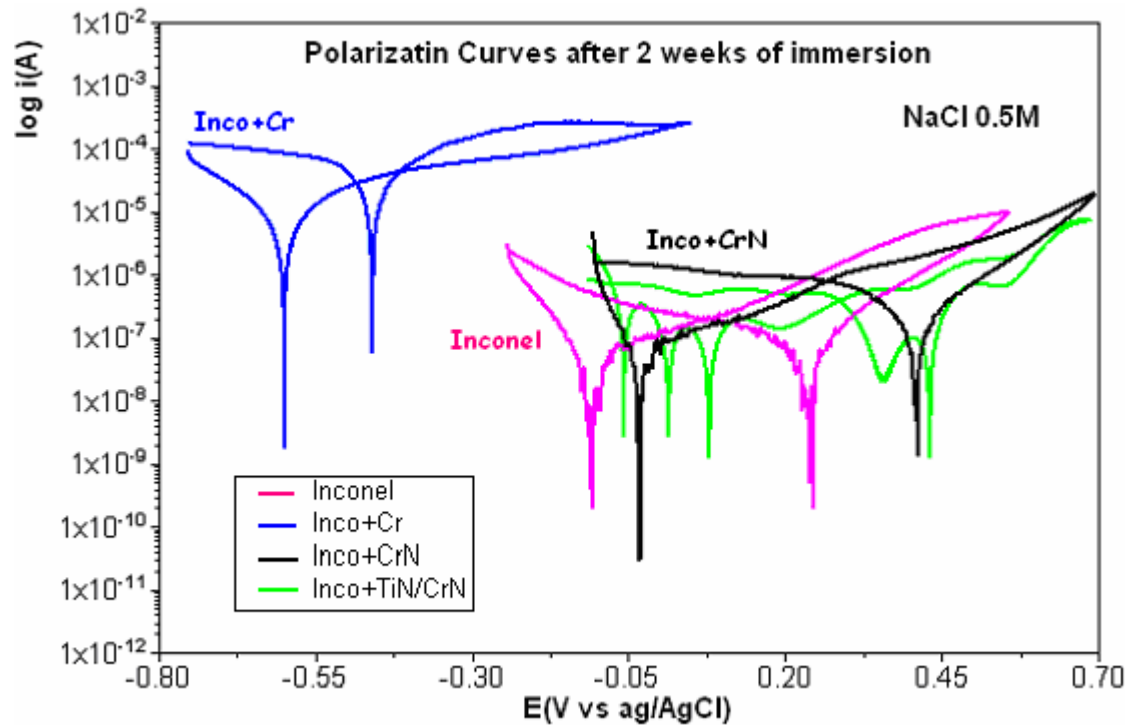
Polarization curves

E _{corr} (V)	I _{corr} (nA/cm ²)
Inconel	-0.11	4.55
Inco+Cr	-0.60	4346
Inco+CrN	-0.03	5.53
Inco+TiN/CrN	-0.06	25.88

- ✓ Low corrosion currents ~ 10^{-9} A/cm²
- ✓ Passive behaviour

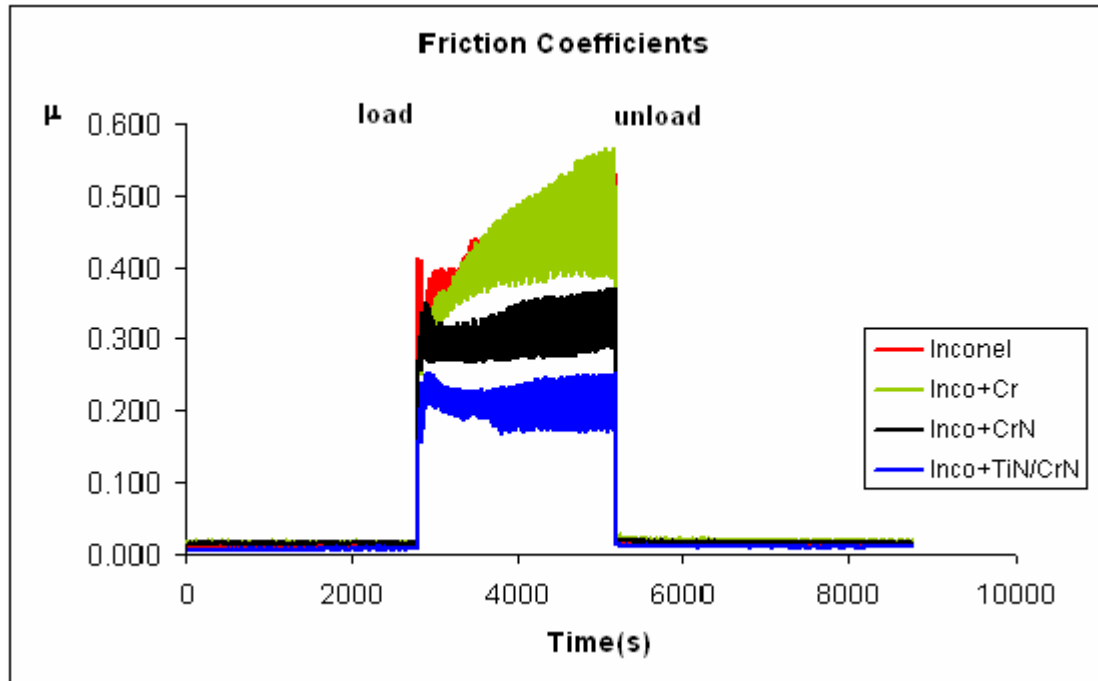
Tribocorrosion - Results

Mean μ
Inco	0.439
Inco+Cr	0.460
Inco+CrN	0.322
Inco+TiN/CrN	0.213

✓ High friction coefficients due to the non lubricated contact

✓ PVD layers reduce friction specially **TiN/CrN** multilayer

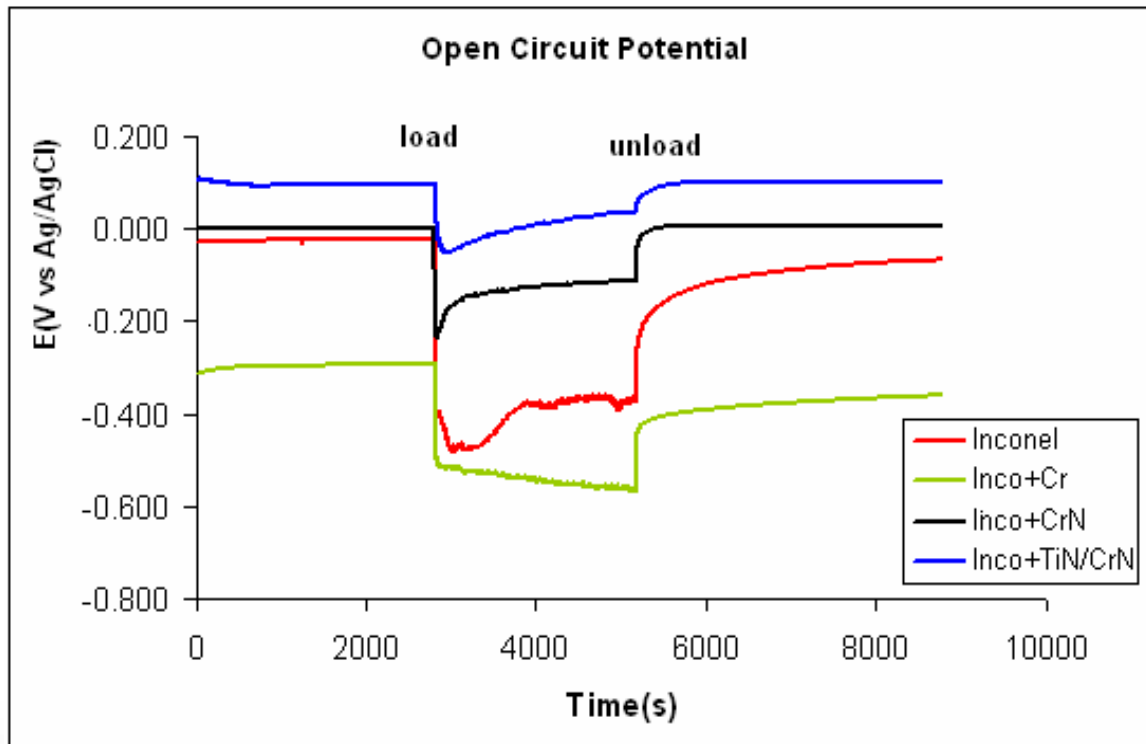
Potential measurements during wear process

Inconel suffer the most significant potential drop from **-0.024 V** to **-0.479 V**

3600s after stop rubbing, the potential in Inconel and Inco+Cr surfaces has not reached yet its initial values

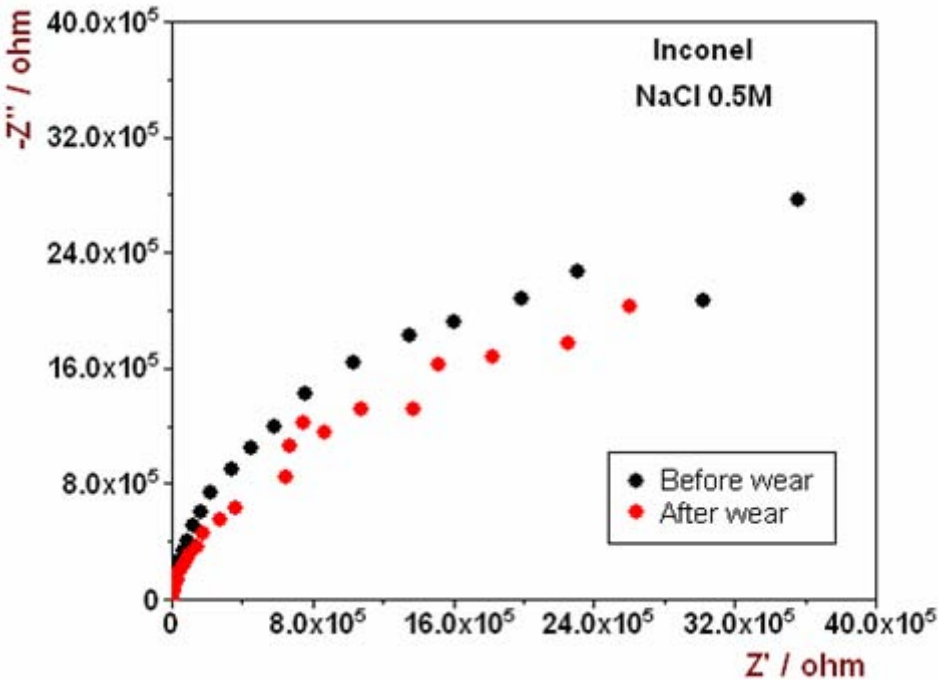
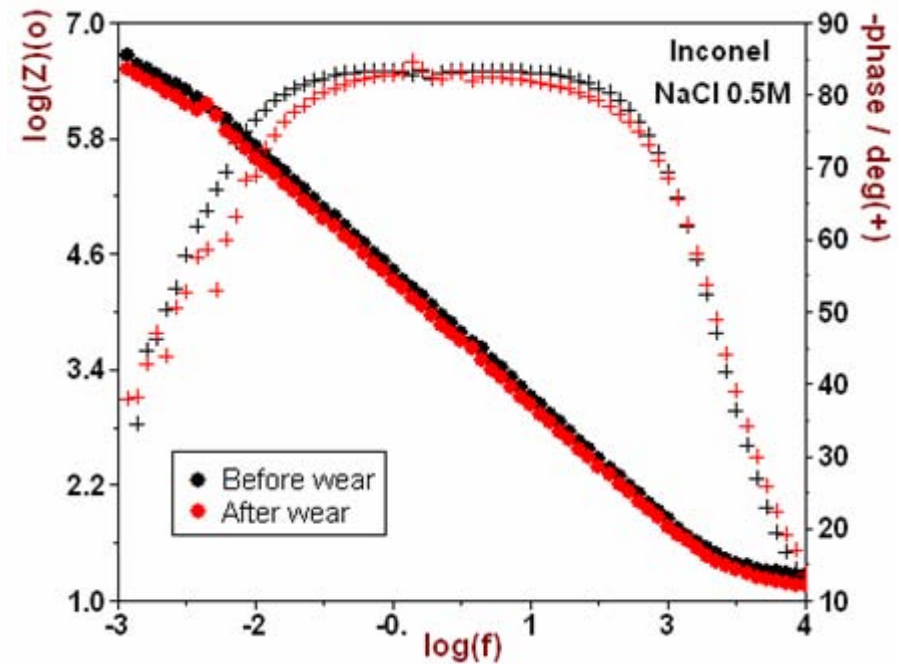
EIS measurements before and after the wear

- ✓ Corrosion resistance decreases slightly after wear due to the depassivation process on the worn surface area
- ✓ Mechanical effects influence on the Inconel corrosion behaviour

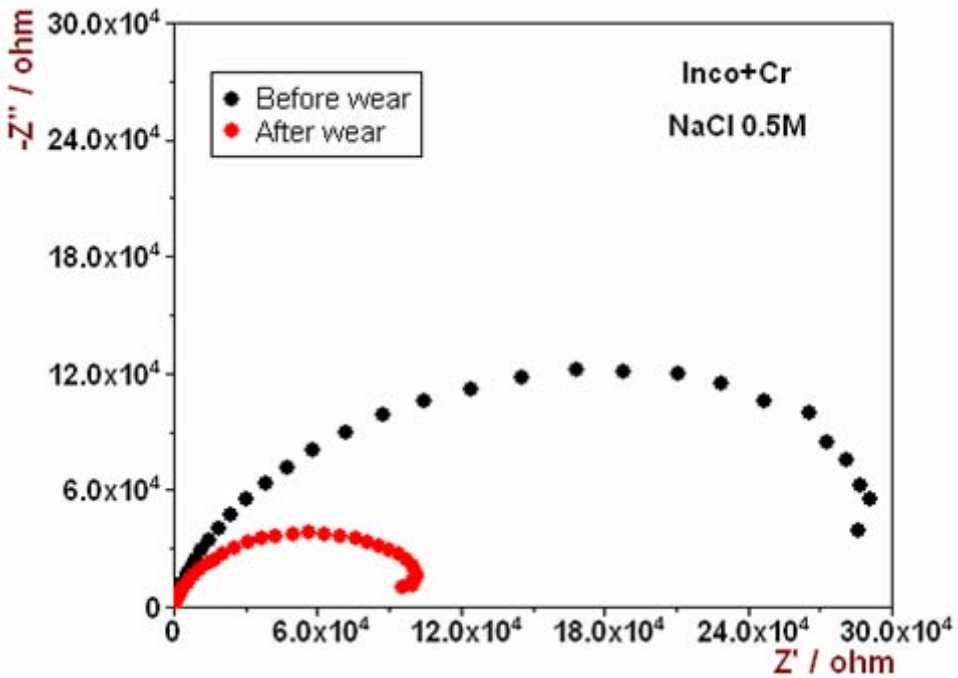
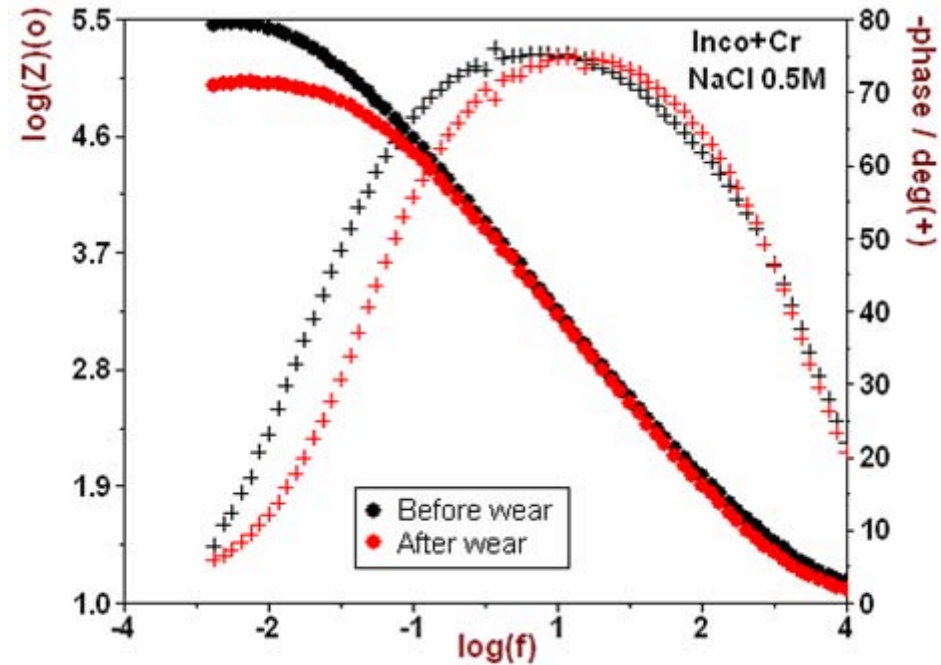
- ✓ Electrochemical surface state of hard chromium coating differs notably before and after wear
- ✓ Mechanical effects reduce its corrosion resistance by altering the formation the protective oxide film on the surface

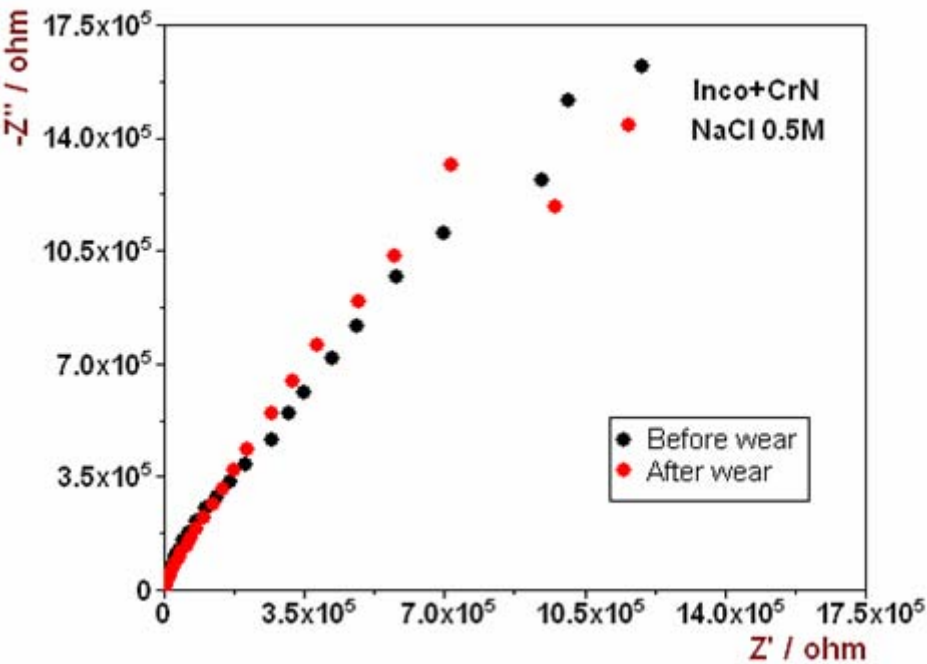
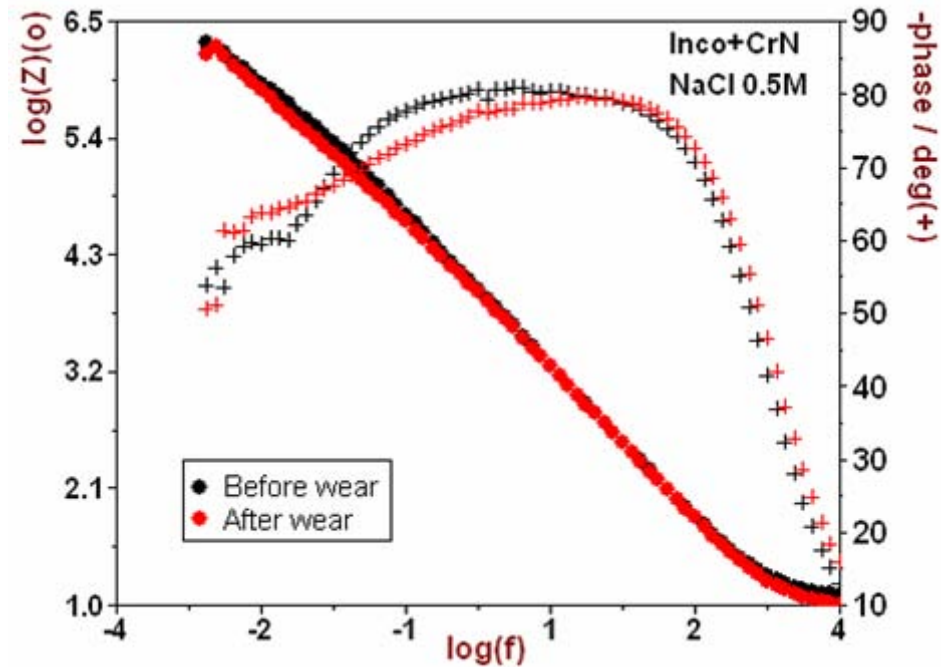
- ✓ Electrochemical surface state of **CrN** is similar before and after wear
- ✓ Mechanical effects have not affected the corrosion behaviour of the coated surface. Worn area repassivates quickly after rubbing process

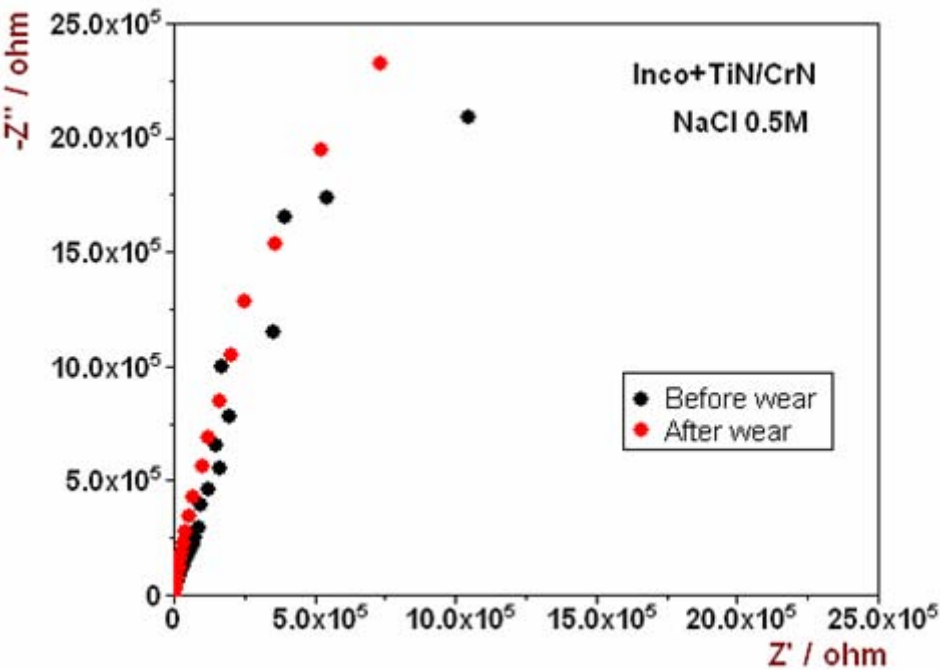
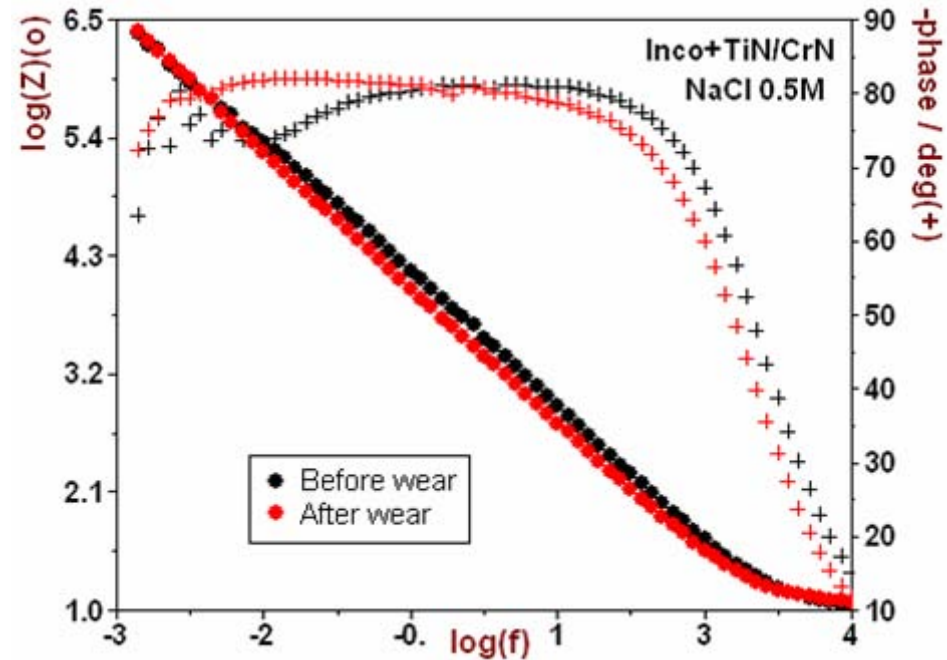
- ✓ Electrochemical surface state of multilayer **TiN/CrN** is also similar before and after wear showing the highest corrosion resistance under wear conditions
- ✓ The worn area repassivates quickly after rubbing

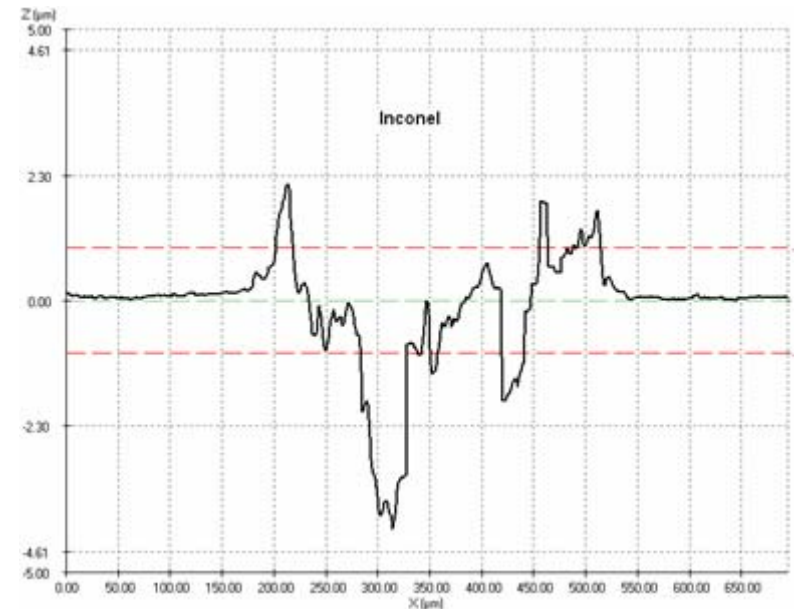
- ✓ Inconel wear track shows strong abrasion and cracks.
- ✓ Track depth reach 4 μm

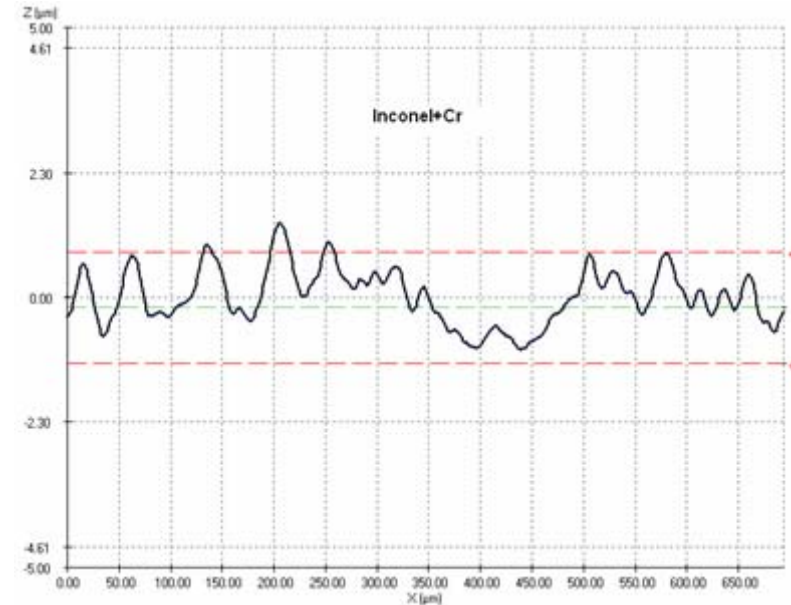
Inco+Cr wear track

- ✓ Chromium coating topography reveals low wear (small loss of volume)
- ✓ Track depth is around 1 μm

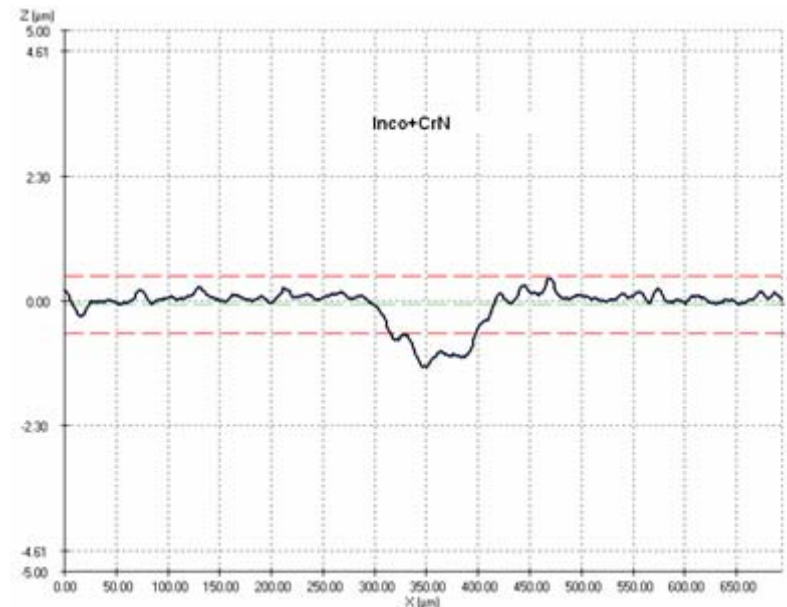
Inco+CrN wear track

✓ CrN coating topography reveals low wear and abrasion marks

✓ Track depth is similar to the obtained in chromium coated surface, around 1 μm , the substrate have been protected during rubbing by the coating

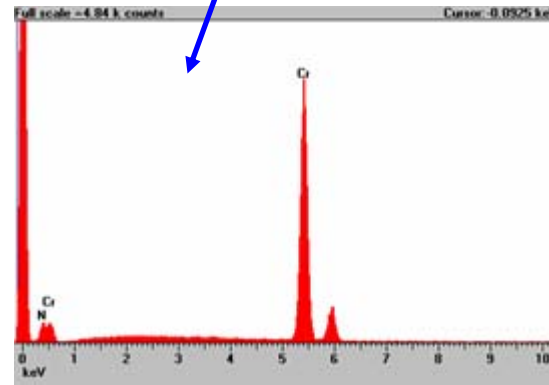
Inco+CrN wear track

Same composition
outside and inside
the track

Negligible wear,
smoothed effect
